ASBESTOS SURVEY FOR FORT POINT U.S. COAST GUARD STATION

Presidio of San Francisco

**Prepared by:
R.L. Stollar & Associates, Inc.
Urie Environmental Health, Inc.**

September 1991

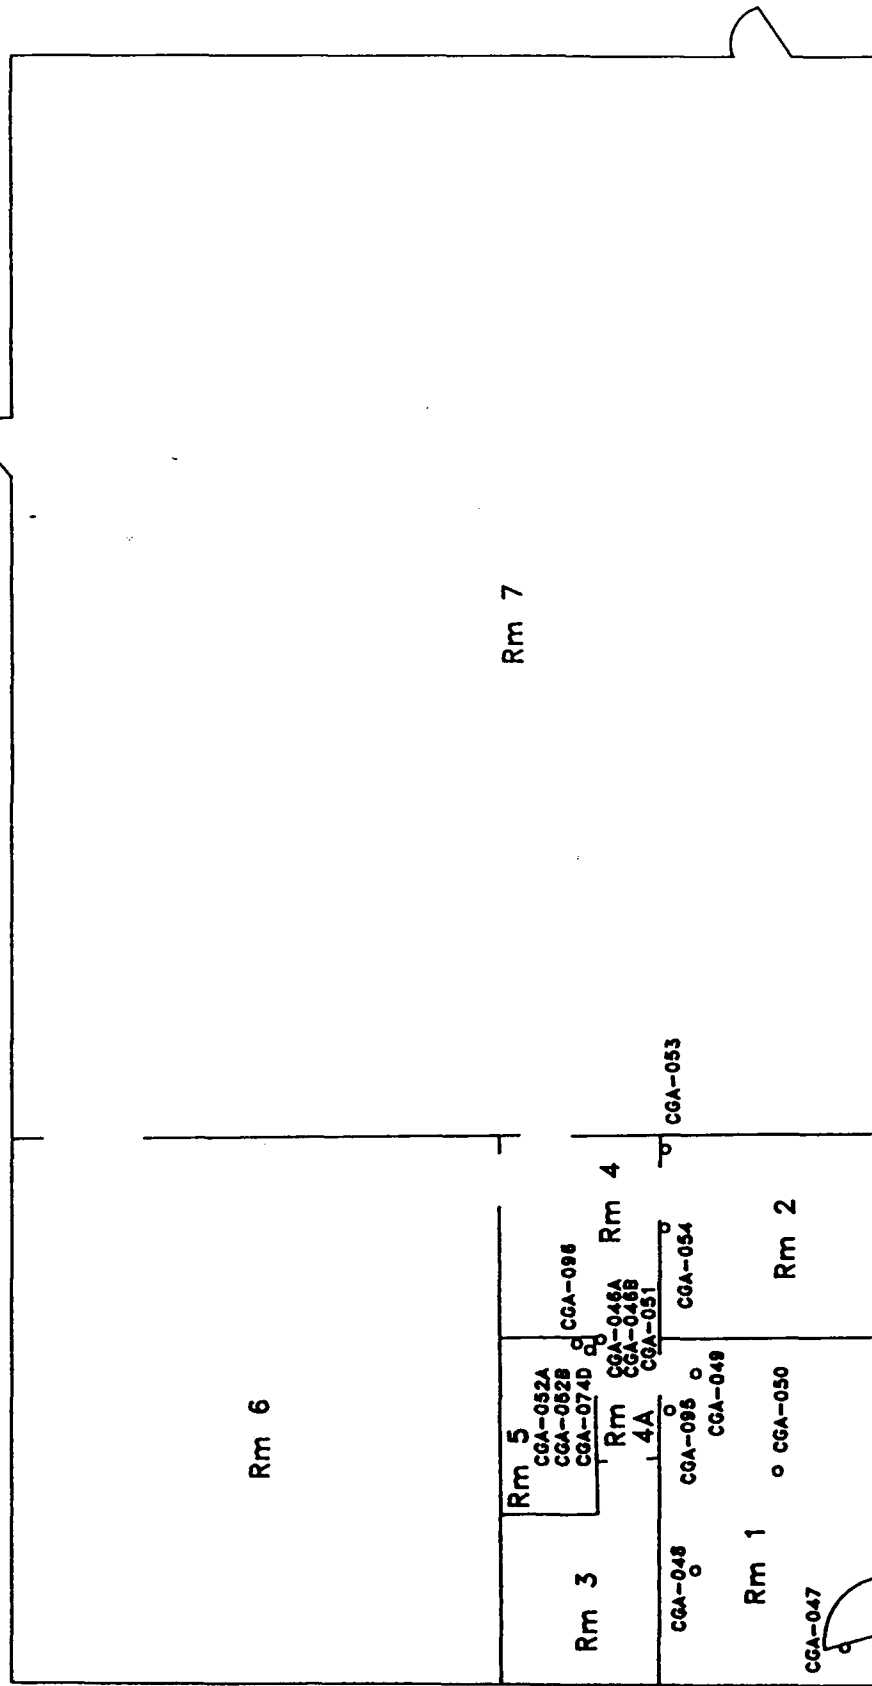
FLOOR PLAN & SAMPLE LOCATIONS
BLDG 984, FIRST FLOOR
FT. POINT U.S. COAST GUARD STATION
ASBESTOS SURVEY

Building 994 contains 228 sq ft of ceiling tile which contains 1-5 percent chrysotile asbestos. Joint compound samples collected here also contained 1-5 percent chrysotile asbestos. Approximately 350 sq ft of floor tile and mastic in Building 994 was found to contain 5-10 percent chrysotile asbestos.

Sample CGA-049 was taken from one of two types of ceiling panels in Room 1. Laboratory analysis of this sample indicates 1-5 percent chrysotile asbestos content. Ceiling tiles are found only in Room 1.

Both nonfriable samples testing positive for asbestos are associated with 9-in. floor tile found in Rooms 1, 3, and 4A. The samples were taken from tile in Room 4A. Sample CGA-046A is from the tile itself, while sample CGA-046B is from the tile mastic. Laboratory analysis indicates 5-10 percent chrysotile asbestos in each of the samples.
